Contract #: 04-0120F4Cty: SF/ALA Rte: 80 PM: 13.2/13.9File #: 13.28**WELDING INSPECTION REPORT****Resident Engineer:** Pursell, Gary**Address:** 333 Burma Road**City:** Oakland, CA 94607**Report No:** WIR-014702**Date Inspected:** 11-Jun-2010**Project Name:** SAS Superstructure**OSM Arrival Time:** 1000**Prime Contractor:** American Bridge/Fluor Enterprises, a JV**OSM Departure Time:** 1830**Contractor:** Oregon Iron Works Clackamas, Or.**Location:** Clackamas, OR

Hinge-K Pipe Beam Assembly 101A-3:

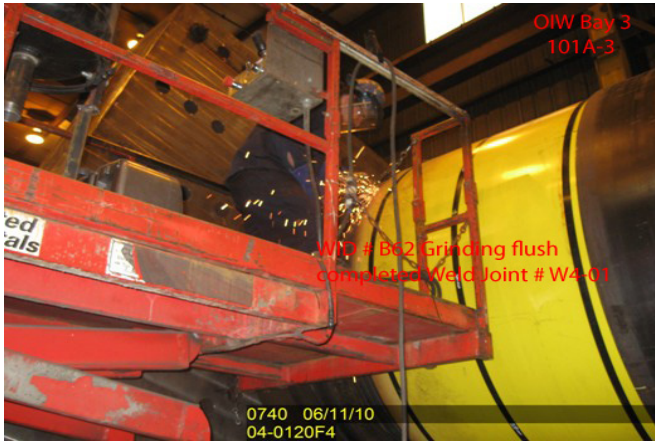
The QA Inspector observed WID # B62 (Marcus Belgarde) performing grinding on the Weld Joint #W4-01. The QA Inspector noted that this Complete Joint Penetration (AWS D1.5 B-U7-S), was the Fuse 120A-3 to Forging 102A-3 and that the grinding was being performed from a scissor lift and the assembly was being slowly rotated, for ease and accessibility of grinding. The QA Inspector observed that the grinding was being performed to remove the weld cap material flush with the base metal, per the contract requirements. The QA Inspector observed WID # B62 was utilizing a hand held grinder with an attached 9" grinding wheel.

The QA Inspector observed that the grinding had been performed throughout the entire shift and OIW explained that swing shift will continue until complete.

The QA Inspector noted that the above mentioned weld joint is still pending final UT, after 72 hrs. cooling time, per AWS D1.5. See attached picture below.
